LANGLEY RESEARCH CENTER

SA-01-89

SUBJECT: MTS Systems Welded-End Accumulators

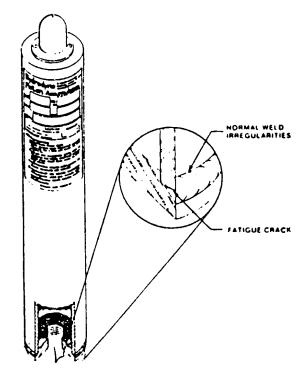
FIGURE 1
TYPICAL WELDED ACCUMULATOR

MTS has discovered such fatigue cracks in the housing of welded-end accumulators purchased during this period from Hydrodyne Industries, a former MTS supplier. These cracks present two potential hazards: 1) the pressure cylinder may completely separate and become a flying projectile and 2) there may be high velocity or high volume leakage of hydraulic fluid.

Examine the fluid end of the accumulator for a weld (see Figure 1). If a weld is present, proceed with steps 3-4.

Any fatigue crack which may be developing in the accumulator weld will not necessarily be externally visible. The presence or absence of a crack should never be used as a criteria for whether or not to replace the accumulator.

THESE WELDED-END ACCUMULATORS SHOULD BE DEEMED TO HAVE REACHED THE END OF THEIR USEFUL LIFE AND SHOULD BE REPLACED.

- 3. Completely discharge the nitrogen pre-charge in the accumulator. Remove the gas valve and discard.
- 4. Contact the Safety Office at extension 43367 for further directions.
